Safety Bulletin

CSB Video - "No Detection: Explosion at Watson Grinding"

Incident Overview

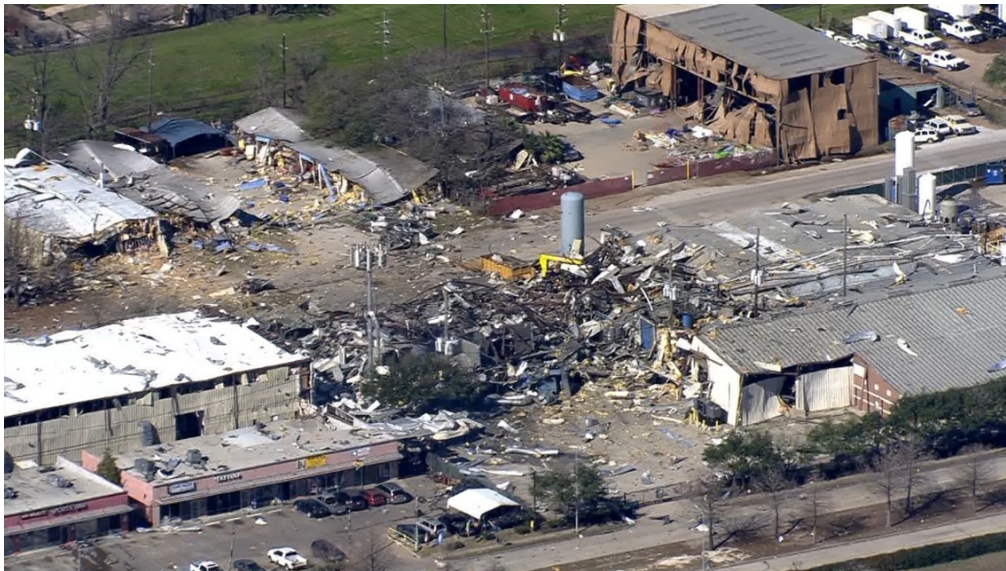
On January 24, 2020, a catastrophic explosion occurred at Watson Grinding and Manufacturing, a precision machining and coatings facility in Houston, Texas. The explosion was triggered by an undetected propylene gas leak, resulting in the deaths of two employees, severe damage to nearby businesses and homes, and multiple injuries. The U.S. Chemical Safety Board (CSB) conducted an in-depth investigation to identify the causes of the explosion and propose safety improvements.
